Moisture safety strategy for construction of CLT structures in a coastal Nordic climate

Berit Time^{1*}, Erlend Andenæs², Trygve Karlsen³, Stig Geving¹, and Tore Kvande²

2. Moisture safety strategy in the ZEB Laboratory

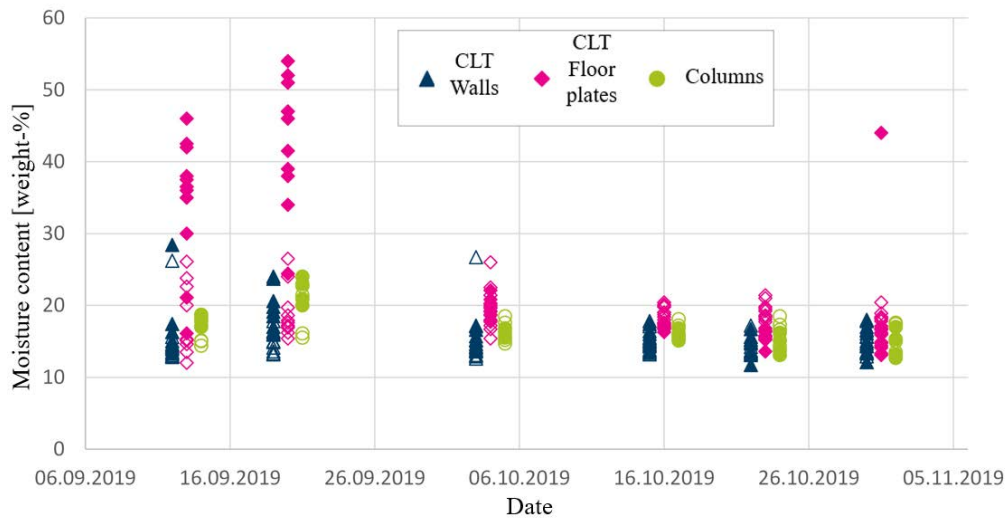
Figure 2 shows the dates and results of the manual wood moisture measurements, as well as the temperature and precipitation in the final weeks of building envelope assembly. Figure 3 shows the results of the manual wood moisture measurements. The outlying data point in the final set of measurements (October 31) was caused by a puddle that had formed on the floor plate, as the door to the exterior scaffolding elevator had not been closed properly overnight.

Figure 3: Measured wood moisture content, in weight-%, at the six times of manual measurement (M1-M6).

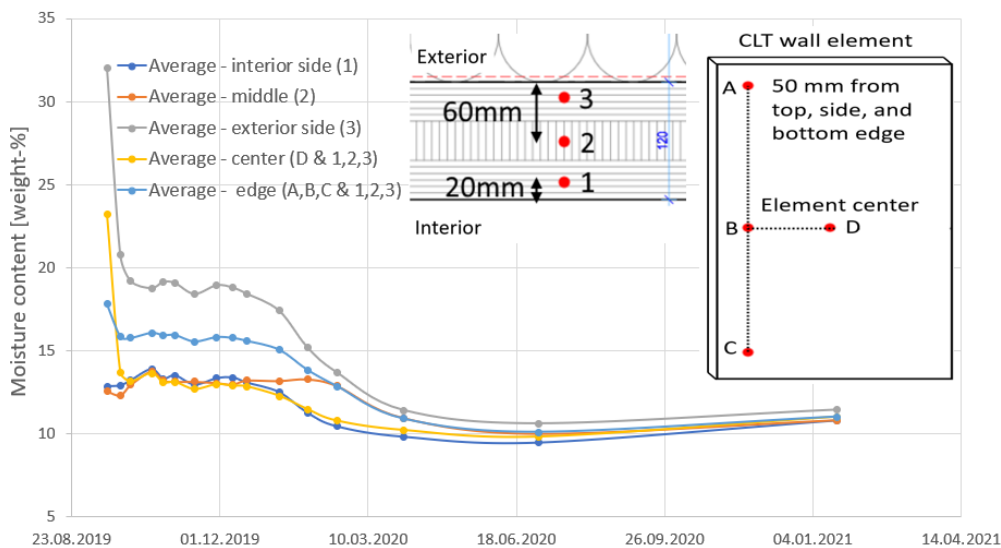
Figure 4 shows the moisture measurements from the fixed moisture sensors in the CLT wall element, and their placement. The measurements indicate that the structure dried quite quickly after assembly and remained at acceptable levels of moisture in the long term. The exterior side and edge exhibited higher moisture levels initially. Moisture levels across the whole element converged relatively quickly after the building envelope was completed in November 2019.

Figure 4: Moisture development in a CLT wall element, measured by fixed sensors.

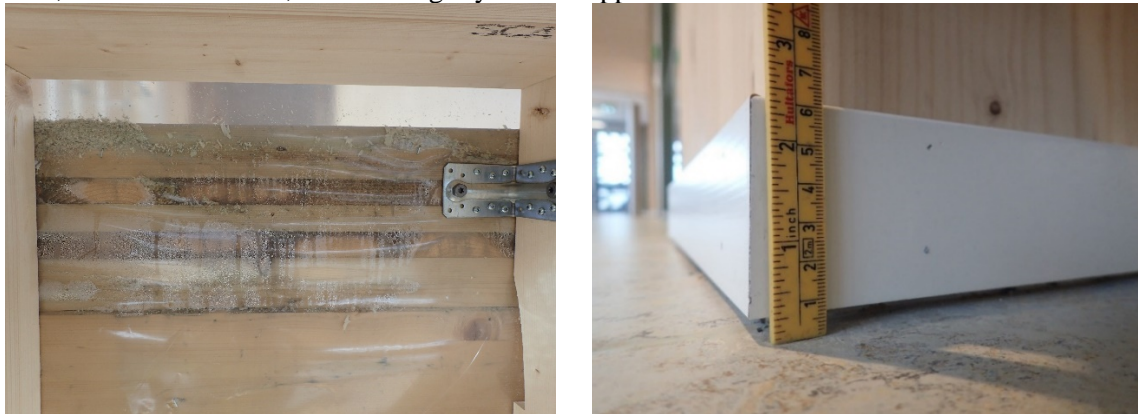
Minor moisture damage was observed during the construction phase. The vapour barrier was mounted along the edge of the CLT floor plates early during construction as seen in Figure 5. Moisture was trapped beneath it, and some visible mould growth occurred. The entrapped moisture originated from flowing water on the surface of the floor plates and would not reappear after the building envelope had been completed. Ventilating the space allowed the surface to dry. Additionally, despite the efforts, moisture and solar radiation caused some stains on wooden surfaces. Most of these were sanded off and coated, but some surfaces were inaccessible – for instance, above the drop ceiling or inside technical shafts. The back side of diagonal elements placed in front of windows were also inaccessible, causing stains to be visible from the outside.

Deflection was also observed along the floor throughout the building, requiring some readjustments of baseboards as shown in Figure 5. It could not be determined whether this was caused by contraction of the CLT floor plates, or creep of the acoustic floor. The acoustic floor plate could not be fitted properly along certain portions of the interior walls, due to the insertion of doors or glazing. The floor was expected, and later observed, to creak slightly when stepped on in these locations.

Figure 5: Left: Entrapped moisture behind vapour barrier during construction. Right: Deflection of floor due to creep and shrinkage, necessitating repositioning of the baseboard.
