Moisture safety strategy for construction of CLT structures in a coastal Nordic climate

Berit Time^{1*}, Erlend Andenæs², Trygve Karlsen³, Stig Geving¹, and Tore Kvande²

2. Moisture safety strategy in the ZEB Laboratory

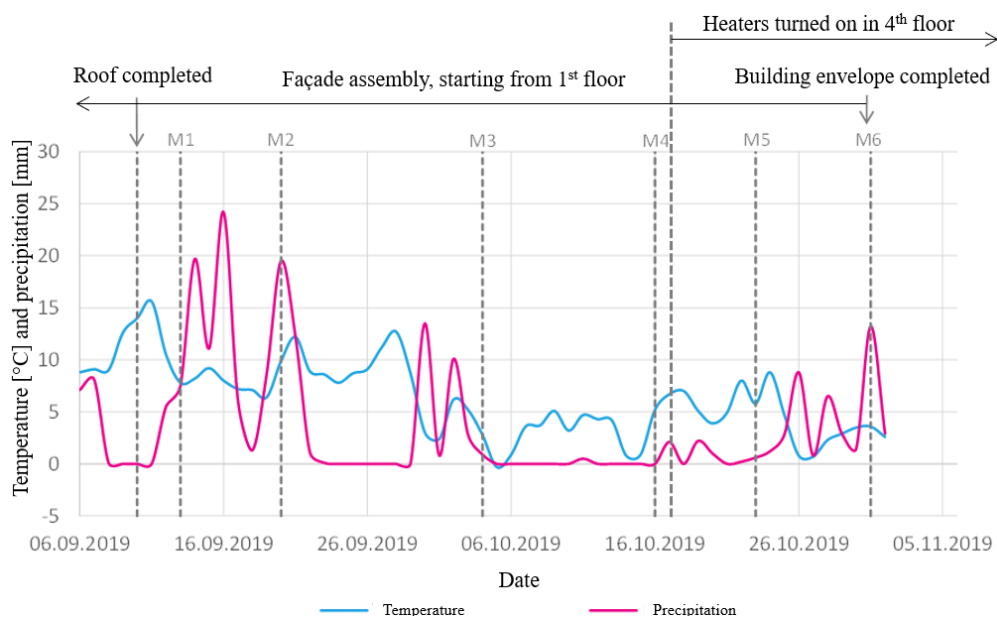
Figure 2 shows the dates and results of the manual wood moisture measurements, as well as the temperature and precipitation in the final weeks of building envelope assembly. Figure 3 shows the results of the manual wood moisture measurements. The outlying data point in the final set of measurements (October 31) was caused by a puddle that had formed on the floor plate, as the door to the exterior scaffolding elevator had not been closed properly overnight.

Figure 2: Outdoor temperature and precipitation at the time of manual measurements. Relevant events in the construction timeline are also marked.
